INVESTIGATION OF THE DURABILITY OF CEMENT DRAIN TILE IN ALKALI SOILS

(CONTAINING RESULTS OF FIRST YEAR'S TESTS)

R. J. WIG, Engineer Physicist
and

ISSUED JULY 22, 1915

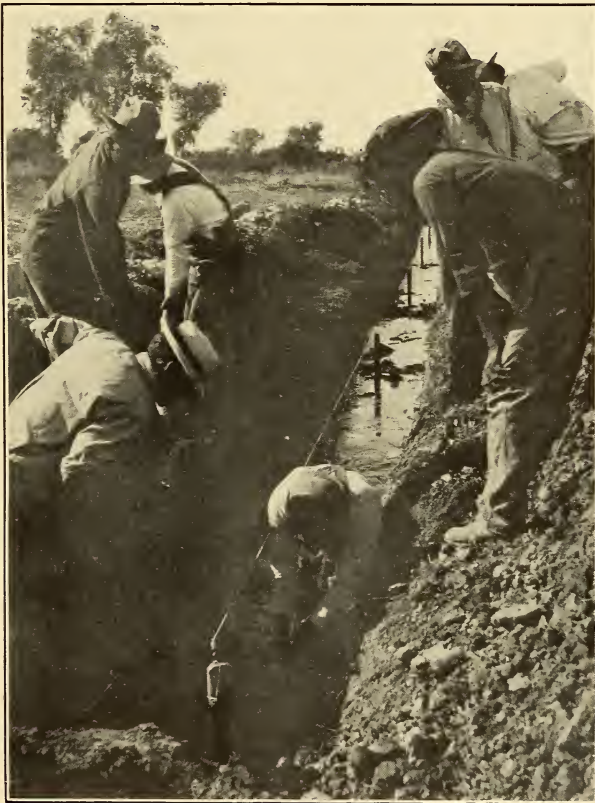
FIG. 33.—View of opened ditch at Yuma, Ariz., showing heavy flow of seepage water in the bottom; also the method of placing the tile

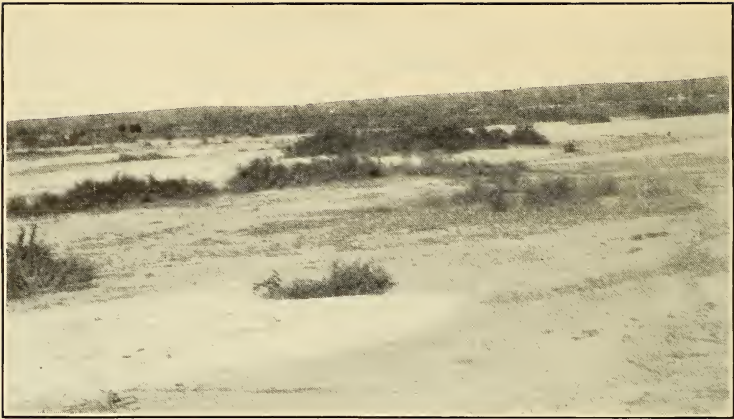
The outlet of the line was placed in the wooden manhole of a drain which had been previously constructed and extended northeast in a straight line with a uniform rise of 0.1 foot per 100 feet. The depth averaged about 6.5 feet, with the exception that the upper 150 feet had a depth of about 5.5 feet. During the installation the ground water stood about 4 feet above grade, causing the sides of the trench to cave unless well braced. A wooden manhole was placed at the end of the tenth "A" section, and an observation well at the upper end of the line. Three tile were found broken in the car and one was broken in hauling to the drain site, so that the breakage was approximately one-half of 1 per cent. Fig. 35 shows the work in progress at Roswell.

FIG. 35.—View from lower end of opened ditch for experimental drain at Roswell, N. Mex., showing tile strewn ready for placing. Note the entire trench is partly excavated and banks are vertical. The concentration of salts is not as great at this project as at some of the others

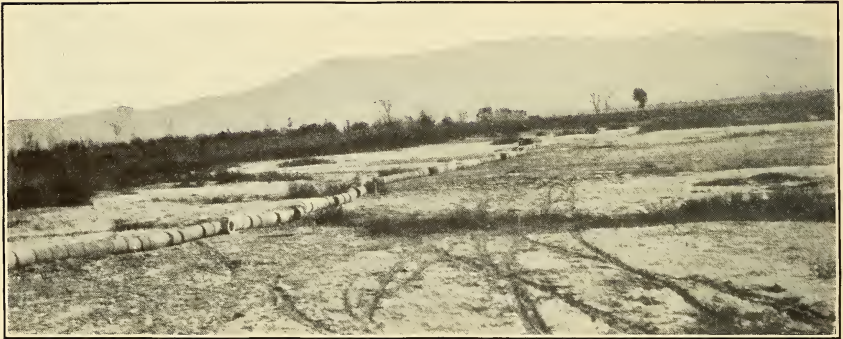
of drainage investigations, Department of Agriculture. This land had previously been irrigated and cultivated, but was later abandoned on account of the concentration of alkali on the surface and in the upper part of the soil. At the time the experimental tile were placed the surface was entirely covered with a thick white coating of alkali salts, as shown in the accompanying photographs. (See Figs. 37 and 38.)

FIG. 37.—View of site of experimental drain at Grand Junction, Colo., showing extremely heavy concentration of alkali salts on the surface of the ground. There is practically no vegetation other than alkali weed. Observe the salts are more concentrated on the high spots

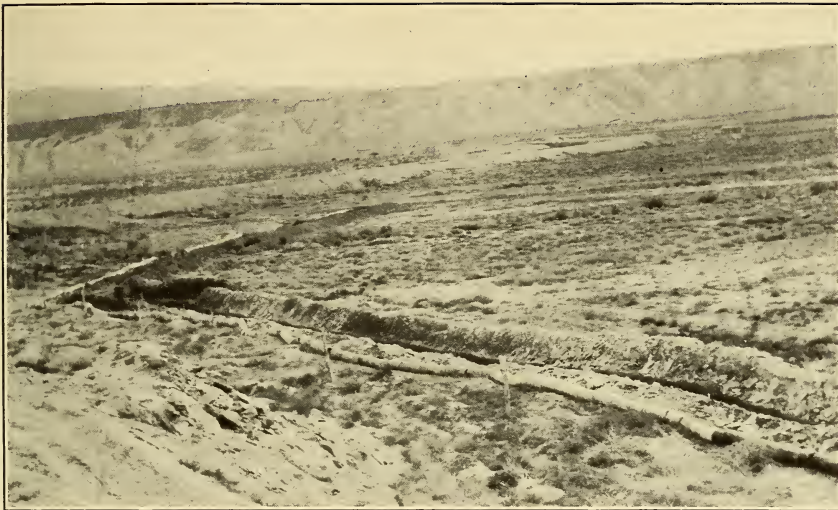
FIG. 41.—View from upper end of site of experimental drain at Montrose, Colo., showing the opened ditch and the distribution of the tiles just previous to placing. Observe hard shale excavated at upper end to the right in picture

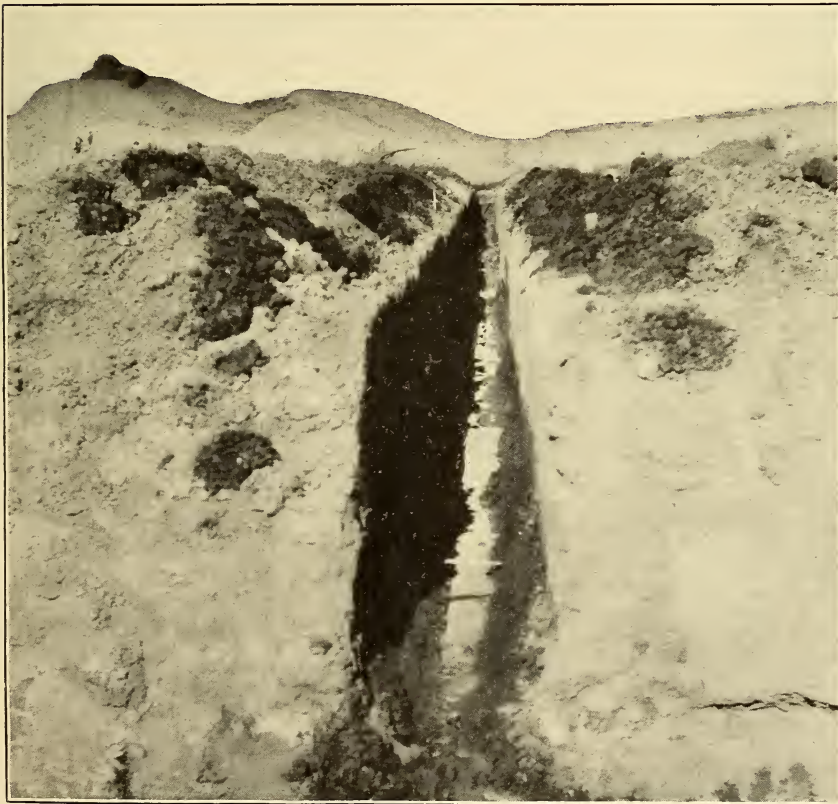
FIG. 42.—Lower end of opened ditch for experimental drain at Montrose, Colo., showing depth of completed trench, flow of seepage water, and alkali salts on surface of soil where partially dried in the foreground

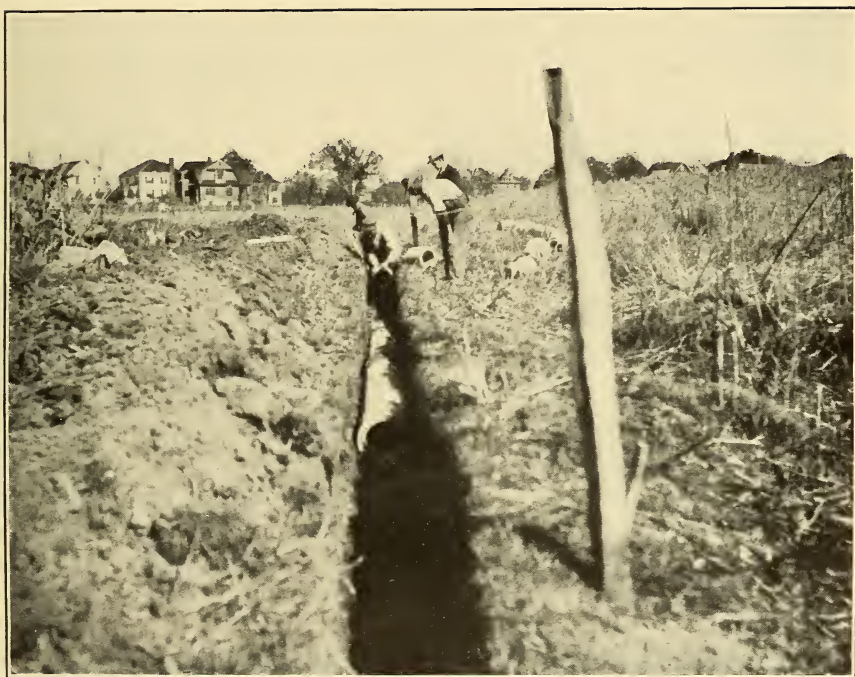
FIG. 44.—Lower end of experimental drain, Columbia, Mo., showing shallow installation of tile necessary on account of high outlet

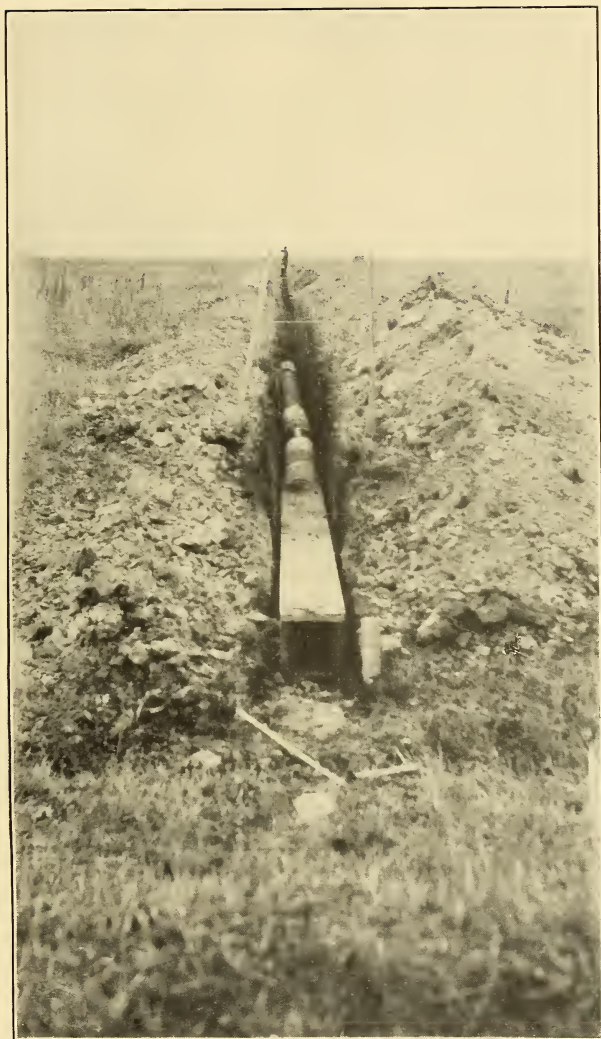
FIG. 46.—Lower end of experimental drain at Crookston, Minn., showing shallow installation of tile with box at outlet to prevent tile being washed out

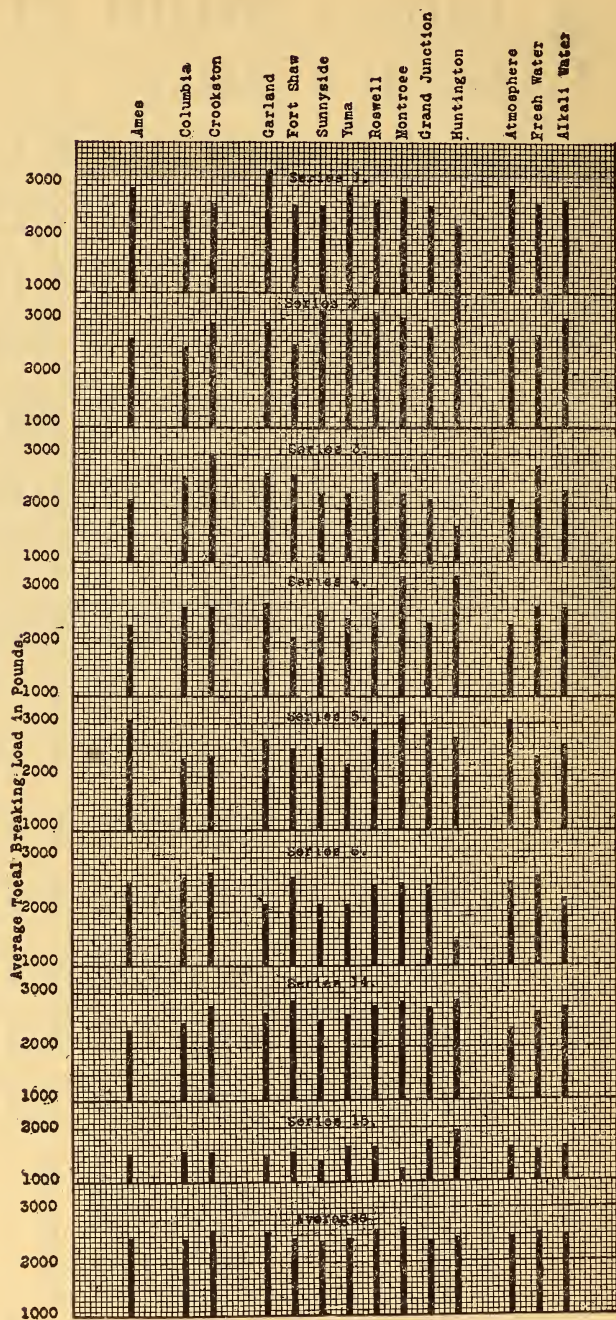
A summary of the results is given in Table 9. The results of tests included in Table 9, are shown diagrammatically in Figs. 48 and 49. It should be emphasized that the breaking tests alone should not be taken as an index of the resistance of the tile to alkali action, as some of those which had a normal or only slightly reduced strength showed evidence of alkali action by softened edges or cracked surfaces. Where such action has been noted it is possible another year or two of exposure may cause the failure of the tile although this need not necessarily result.

FIG. 48.—Results of first year's tests of hand-made cement drain tile. (See Table 9 for detailed results)

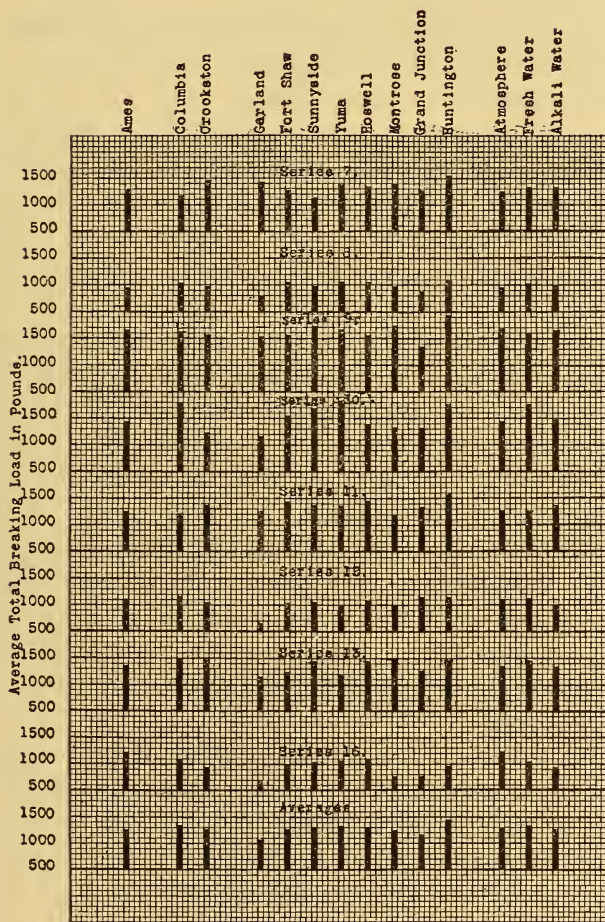
FIG. 49.—Results of first year's tests of machine-made cement drain tile. (See Table 9 for detailed results)
